**INITIAL ASSESSMENT:****Lawson Hill Landslide  
May 3, 2008****Prepared for:**

*San Miguel County  
Sheriff's Department  
851 County Road 63L  
Telluride, CO 81435*

*Buckhorn Geotech, Inc.  
222 South Park Ave.  
Montrose, CO 81401*

**May 13, 2008**

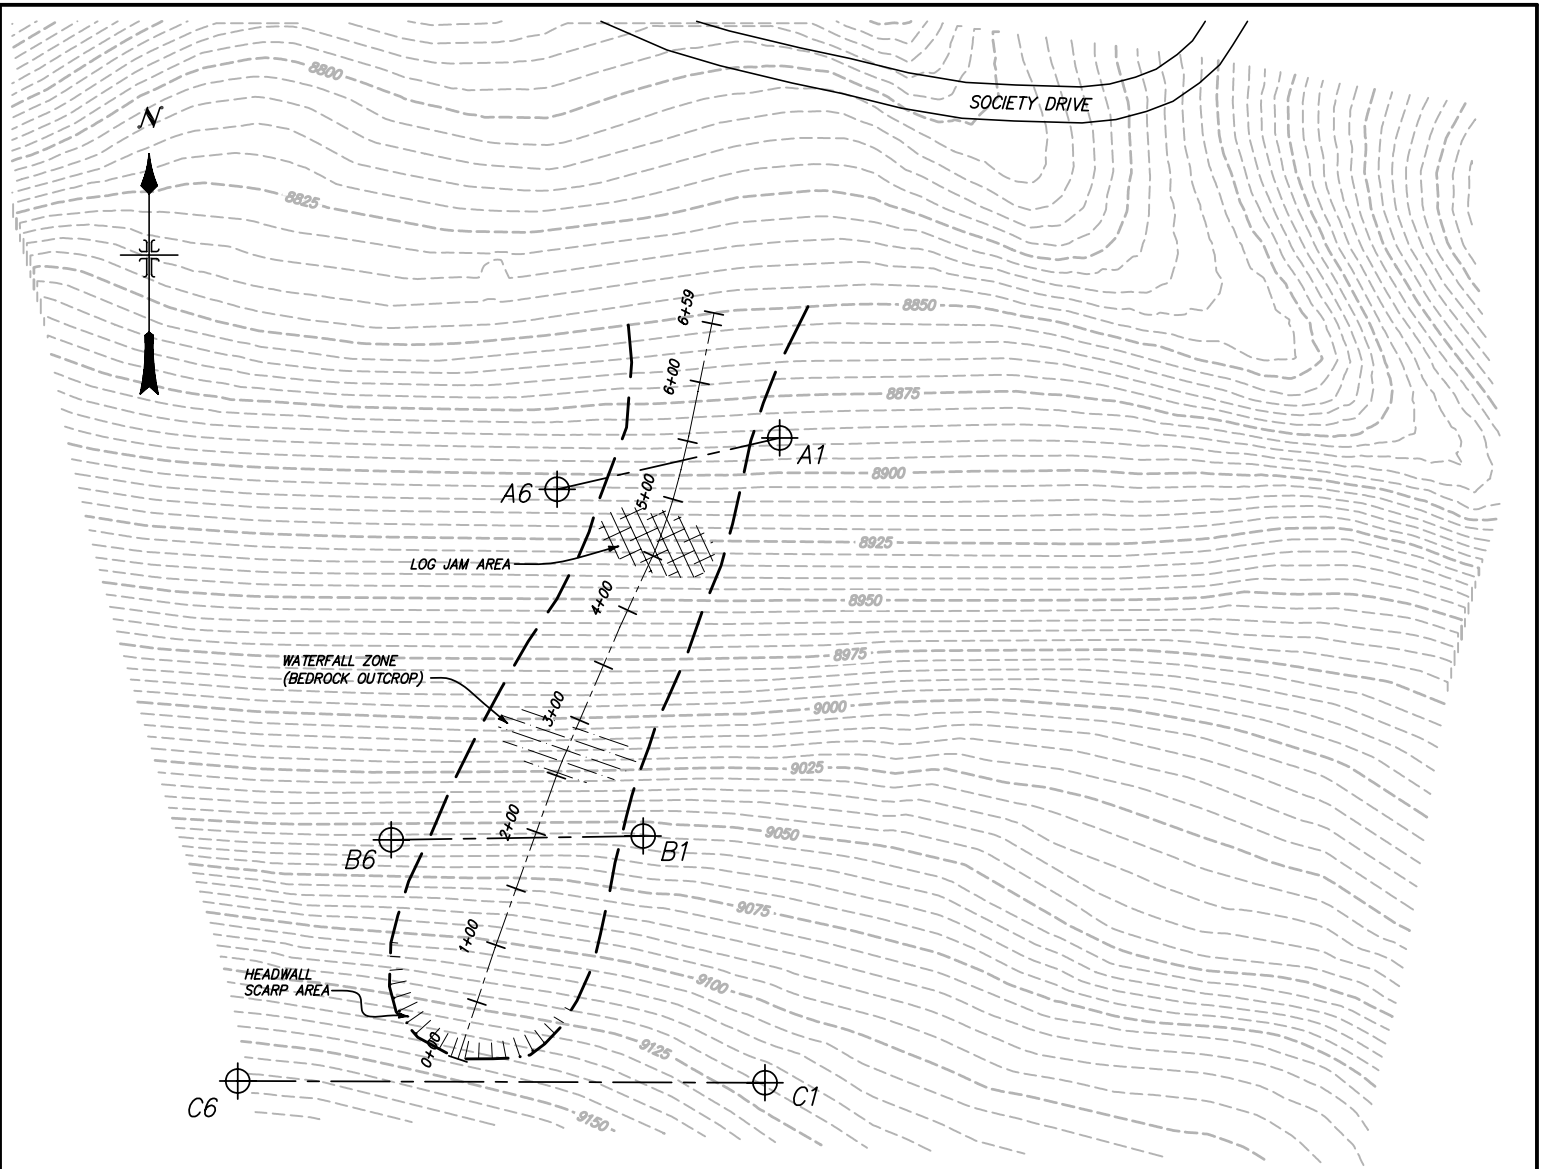
MAP 1

A number of springs are located near the base of the headwall scarp, which are the "smoking gun" evidence of what triggered the landslide (see Map 1). Rapid and intense snowmelt from an approximately 150% of normal snowpack saturated the soils in the hillside above the scarp, infiltrated into the porous glacial moraine deposits and encountered a more impervious surface that perched the excess groundwater. This supposition is supported by an eyewitness account by Daryl Bonin (personal communication: 5/12/08), who observed the slide event and hiked up the hillside shortly after the event to observe the headwall scarp. He saw a "seam of rock about 15 feet down from the top of the escarpment where water was gushing out of the hillside on top of the line of rocks." He indicated that the seam of rock appeared to be sandstone (not shale) and that angular slabs were strewn downslope of the outcrop, evidently plucked and carried downhill during the slide event and subsequent debris flow activity. Mr. Bonin also indicated that the debris flow material throughout the slide had the consistency of "runny pancake mix," as it was saturated and very fluid. By the time we arrived the following day (roughly 16 hours after the event), the bedrock outcrop exposed in the headwall scarp had

Observations made in the field indicate that the steep, middle portion of the slide contains a waterfall that cascades over an outcrop of interbedded sandstone and shale (see Map 1). The water draining from the seeps in the headwall scarp coalesce at the head of this zone and the stream has washed off this exposed surface. The sandstone beds are generally less than 1-foot thick and dip 5 to 6° to the northeast. This outcrop is at roughly the same elevation of a more massive sandstone cliff at the northwest corner of the mesa, around 2,000 feet to the west of the slide, as seen from across the valley and on the geologic map (*Preliminary Geologic Map of the Gray Head Quadrangle*, Bush et al., 1961: USGS Map MF-176). Although the bedrock dips to the north into the valley, which is not generally a desirable direction of dip to preserve slope stability because it can carry water towards the slope surface and lubricate planes of weakness, the sandstone within the Dakota Sandstone formation is typically competent, not highly weathered, and is well-cemented. It appears to us that this more resistant, predominately sandstone unit forms a confining surface for the depth of the failure plane of the landslide. In other words, the depth of the failure could have been much greater, given the steepness of the slope, had it not been for the presence of the harder Dakota Sandstone layers underlying the unconsolidated glacial till and weak, clayey, weathered, Mancos Shale.

The lower portion of the slide consists of the depositional or runout zone which contains a large “log jam” with many trees, mud and rock collected in a mass (see Map 1). Water ponded in this area for the first part of the week of observations, but it slowly drained and was drying substantially by the end of the week. The new stream channel drains through this material, but it appears to reemerge from the downhill side of the pile fairly intact as a channel. This area slows the stream and likely allows for infiltration into the soils, as there appears to be some loss of surface flow. However, it is also a fairly porous debris pile consisting of a chaotic and fairly open mass of trees with retained muddy debris. Although the log jam is an eyesore and a source for potential tree fall, it appears that it is responsible for saving the homes in the immediate path of the mudflow as it served as a dam and a filter. As long as this material stays

We set up three transects (named A, B and C) on Monday, May 5<sup>th</sup> across the landslide area to aid in monitoring slide movement. The transects are shown on Map 1 and were placed generally perpendicular to the direction of flow with end stakes placed on stable land on each (east and west) side that did not move during the landslide event and will not likely move in the near future. Each transect consists of 6 survey stakes with orange tips placed in a straight line. The stakes within the transects are numbered from east to west such that the eastern-most stake on each transect is A1, B1 or C1 and the western-most stake is A6, B6 or C6. The lowest transect (A) was placed below the "log jam" portion of the slide in the earthflow/mudflow runout zone. The middle transect (B) was placed in the steep portion of slide below the headwall scarp and above the "waterfall" or bedrock area in the middle portion of the slide. The upper transect (C) was placed above the headwall scarp to track potential uphill migration of the scarp.
