INITIAL ASSESSMENT:**Lawson Hill Landslide
May 3, 2008****Prepared for:**

*San Miguel County
Sheriff's Department
851 County Road 63L
Telluride, CO 81435*

*Buckhorn Geotech, Inc.
222 South Park Ave.
Montrose, CO 81401*

May 13, 2008

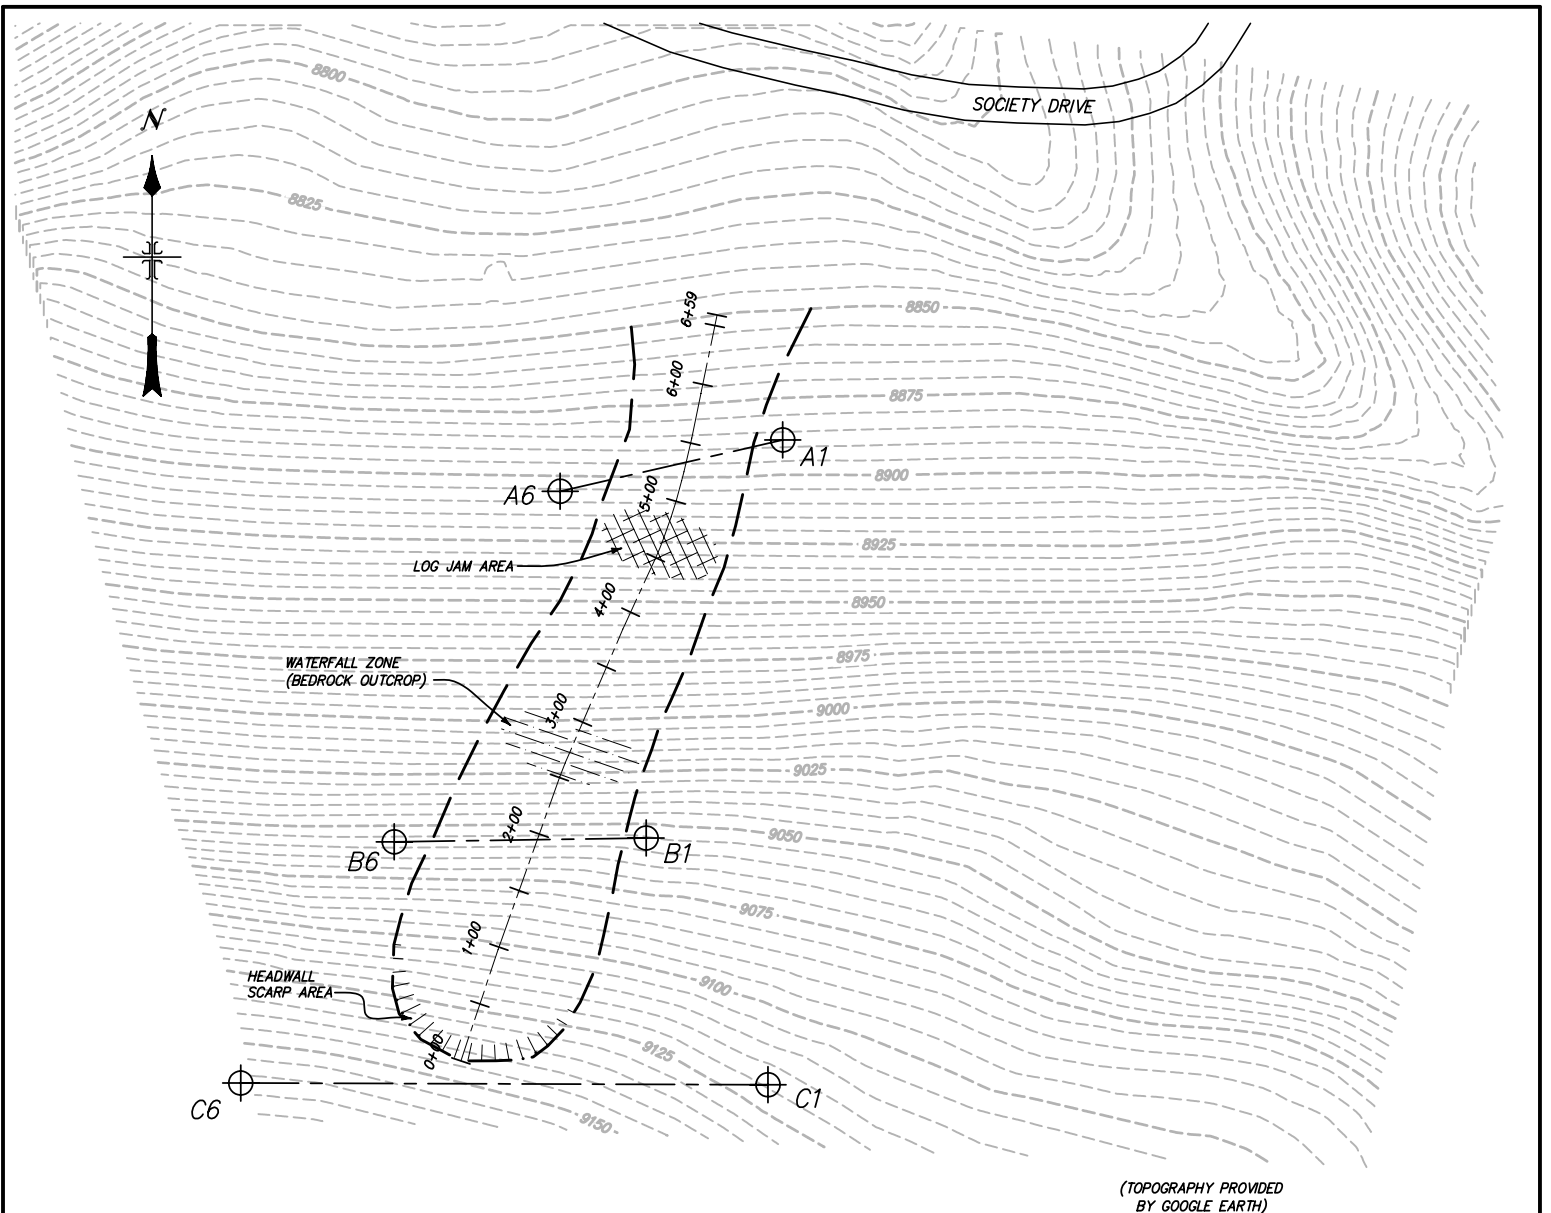
MAP 1	DESIGNER LB
	DRAFTER CB
	DATE 5/13/08
	JOB NO. 08-153-GEO

A number of springs are located near the base of the headwall scarp, which are the "smoking gun" evidence of what triggered the landslide (see Map 1). Rapid and intense snowmelt from an approximately 150% of normal snowpack saturated the soils in the hillside above the scarp, infiltrated into the porous glacial moraine deposits and encountered a more impervious surface that perched the excess groundwater. This supposition is supported by an eyewitness account by Daryl Bonin (personal communication: 5/12/08), who observed the slide event and hiked up the hillside shortly after the event to observe the headwall scarp. He saw a "seam of rock about 15 feet down from the top of the escarpment where water was gushing out of the hillside on top of the line of rocks." He indicated that the seam of rock appeared to be sandstone (not shale) and that angular slabs were strewn downslope of the outcrop, evidently plucked and carried downhill during the slide event and subsequent debris flow activity. Mr. Bonin also indicated that the debris flow material throughout the slide had the consistency of "runny pancake mix," as it was saturated and very fluid. By the time we arrived the following day (roughly 16 hours after the event), the bedrock outcrop exposed in the headwall scarp had

Observations made in the field indicate that the steep, middle portion of the slide contains a waterfall that cascades over an outcrop of interbedded sandstone and shale (see Map 1). The water draining from the seeps in the headwall scarp coalesce at the head of this zone and the stream has washed off this exposed surface. The sandstone beds are generally less than 1-foot thick and dip 5 to 6° to the northeast. This outcrop is at roughly the same elevation of a more massive sandstone cliff at the northwest corner of the mesa, around 2,000 feet to the west of the slide, as seen from across the valley and on the geologic map (*Preliminary Geologic Map of the Gray Head Quadrangle*, Bush et al., 1961: USGS Map MF-176). Although the bedrock dips to the north into the valley, which is not generally a desirable direction of dip to preserve slope stability because it can carry water towards the slope surface and lubricate planes of weakness, the sandstone within the Dakota Sandstone formation is typically competent, not highly weathered, and is well-cemented. It appears to us that this more resistant, predominately sandstone unit forms a confining surface for the depth of the failure plane of the landslide. In other words, the depth of the failure could have been much greater, given the steepness of the slope, had it not been for the presence of the harder Dakota Sandstone layers underlying the unconsolidated glacial till and weak, clayey, weathered, Mancos Shale.

The lower portion of the slide consists of the depositional or runout zone which contains a large “log jam” with many trees, mud and rock collected in a mass (see Map 1). Water ponded in this area for the first part of the week of observations, but it slowly drained and was drying substantially by the end of the week. The new stream channel drains through this material, but it appears to reemerge from the downhill side of the pile fairly intact as a channel. This area slows the stream and likely allows for infiltration into the soils, as there appears to be some loss of surface flow. However, it is also a fairly porous debris pile consisting of a chaotic and fairly open mass of trees with retained muddy debris. Although the log jam is an eyesore and a source for potential tree fall, it appears that it is responsible for saving the homes in the immediate path of the mudflow as it served as a dam and a filter. As long as this material stays

We set up three transects (named A, B and C) on Monday, May 5th across the landslide area to aid in monitoring slide movement. The transects are shown on Map 1 and were placed generally perpendicular to the direction of flow with end stakes placed on stable land on each (east and west) side that did not move during the landslide event and will not likely move in the near future. Each transect consists of 6 survey stakes with orange tips placed in a straight line. The stakes within the transects are numbered from east to west such that the eastern-most stake on each transect is A1, B1 or C1 and the western-most stake is A6, B6 or C6. The lowest transect (A) was placed below the "log jam" portion of the slide in the earthflow/mudflow runout zone. The middle transect (B) was placed in the steep portion of slide below the headwall scarp and above the "waterfall" or bedrock area in the middle portion of the slide. The upper transect (C) was placed above the headwall scarp to track potential uphill migration of the scarp.

SCHEMATIC LANDSLIDE SITE PLAN

APPROXIMATE LENGTH OF LANDSLIDE: 660'
APPROXIMATE VERTICAL EXTENT OF LANDSLIDE: 300'
